# Cooperative Lakes Monitoring Program

## 2014 Data Report for Lake Christiana, Cass County

# Lake Christiana, Cass County

## 2014 CLMP Results

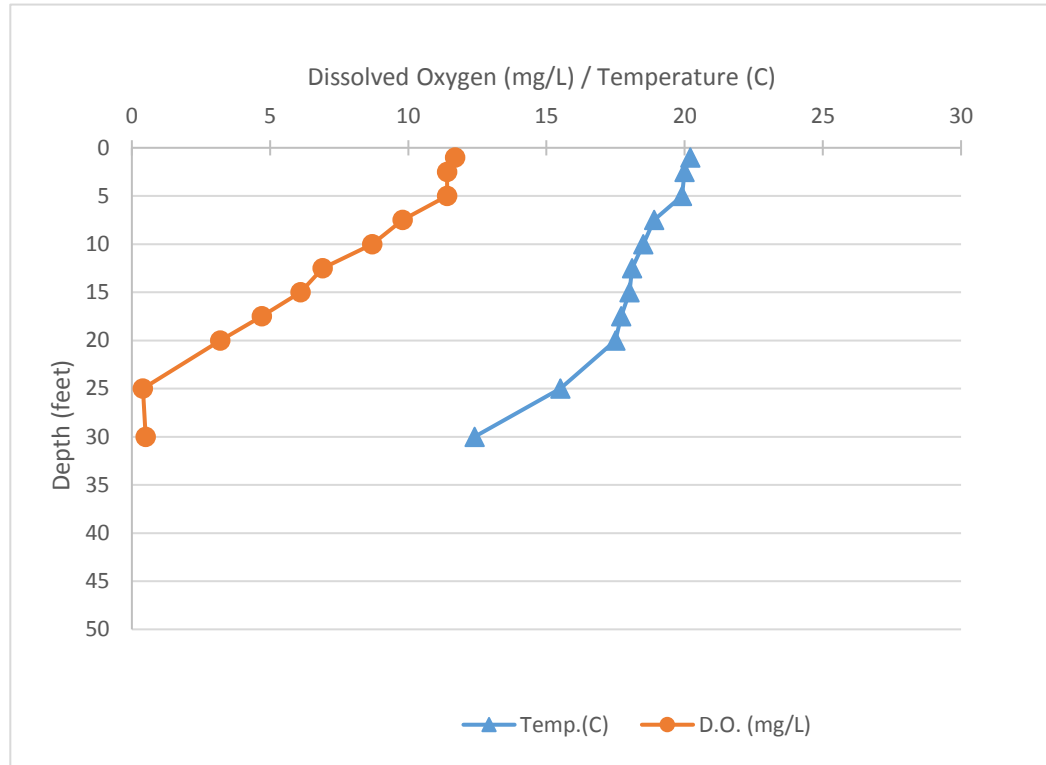
### Dissolved Oxygen and Temperature Profile

Name: Christiana  
County: Cass  
Site ID: 140055  
Date: 9/28/2014

Depth (ft)	Temp.(C)	D.O. (mg/L)
1	20.2	11.7
2.5	20	11.4
5	19.9	11.4
7.5	18.9	9.8
10	18.5	8.7
12.5	18.1	6.9
15	18	6.1
17.5	17.7	4.7
20	17.5	3.2
25	15.5	0.4
30	12.4	0.5
